Ladybarn, Manchester

Project description	Whole house retrofit of mid-terrace house, built c.1888.			
Treated Floor Area	60.5 m ²			
Dates of work	2013			
Project team	Myself (PHPP analyst, project coordinator & builder labour), a local contractor team (Expert Home Extensions), plus additional contractors for plumbing, electrics and plastering.			
Introduction	The house was cold and draughty, with several air bricks at various points in the walls. The bathroom in particular was always cold. The client borrowed some temperature sensors, and we estimated an average temperature in the house of around 15°C, since the client heated only some rooms and not others. The renovation was done as a full-blown learning exercise, where the client agreed to take the risk with us regarding the measures being suggested and projected costs (which ended up being double what I originally estimated). However, accurate timesheets with allocated hours per job has allowed me to have a much better estimate of what various improvements cost (e.g. cost of internal wall insulation per m ²).

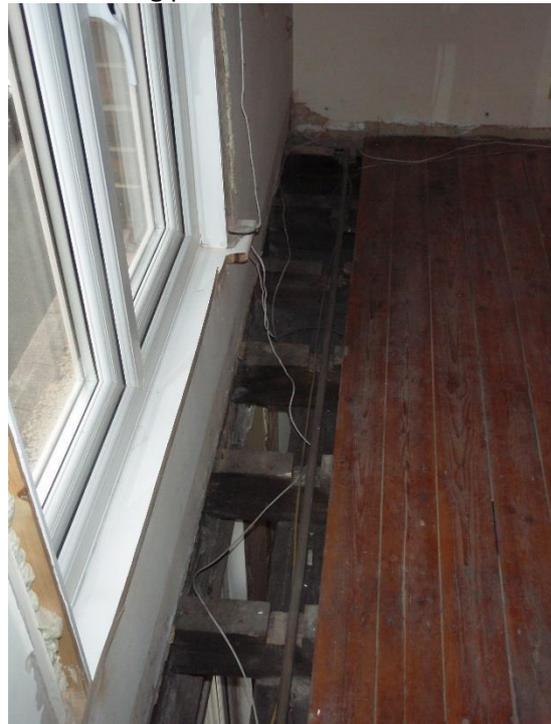
- Insulation was continuous through floor void, which entailed cutting out floorboards and ceiling plasterboard to accommodate it.

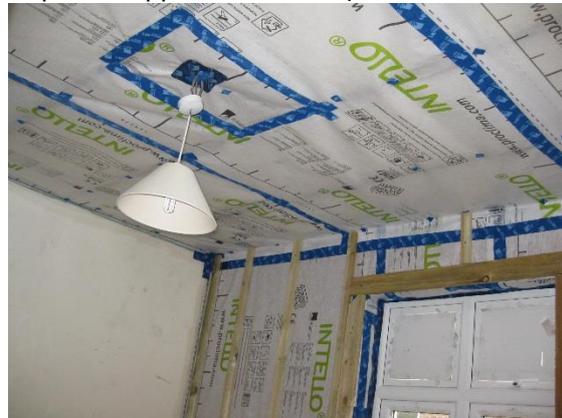
- All service penetrations (e.g. wires, ducts, boiler flue, etc) had to be dealt with using grommets or tapes.
- A 25mm service zone was added in front of membrane on walls for pipes and wires.
- The same type of baton was used for one of the bedroom ceilings in order to aid plasterboard fixing. For the other bedroom ceiling, the membrane was fixed to a more substantial wood frame which was installed to remedy an old sagging ceiling (along with purlin supports in the loft).

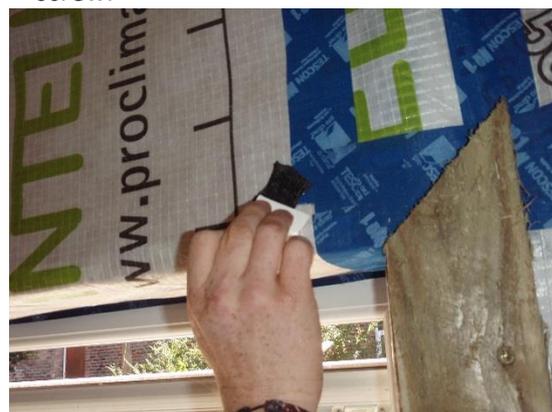
- Naidec (black double-sided sticky tape) was used prior to service zone batons being fixed, in order to maintain airtightness after the drill had created a hole for the concrete screw.

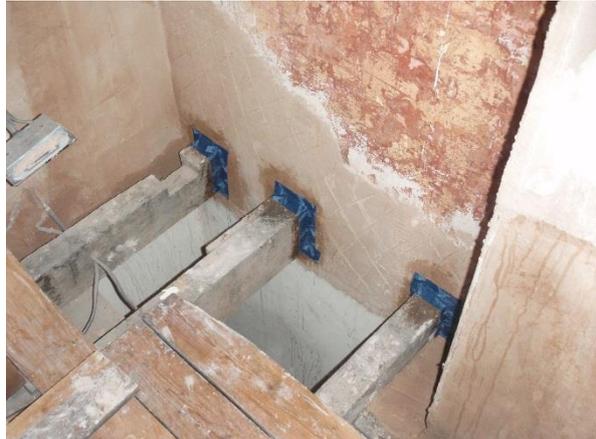
- No membrane was used on the ground floor or party walls – here we relied on the existing surfaces, but for the party wall, this had to be re-plastered in places, and previously unplastered areas (e.g. between floor voids) also had to be plastered.
- After plastering, joist ends were taped to plaster, with a second skim coat over the tapes (we had joist ends going into both party wall and external wall in this house).

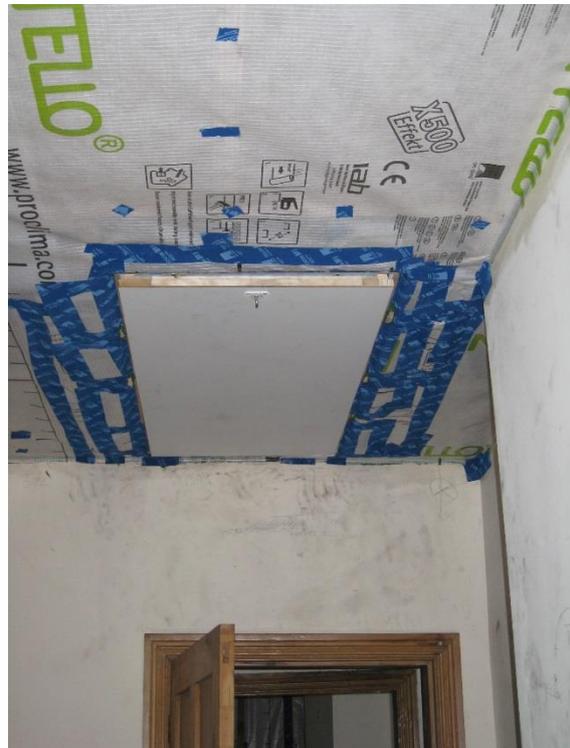
- Airtight loft hatches were installed to access bathroom and bedroom lofts.

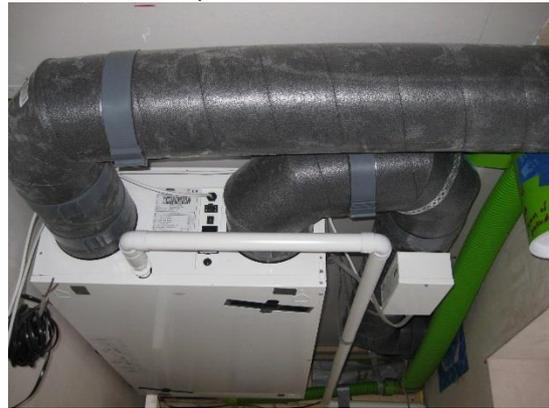
- Brink Renovent Sky 300 unit installed on bathroom ceiling and boxed out
 - o 85% effective dry heat recovery rate (as per Passivhaus test criteria)
 - o Frost pre-heater installed on intake duct
 - o 180mm insulated ductwork connects the unit to external wall cowl.
 - o Condensate is connected to sink waste, with Hepworth valve installed as trap.

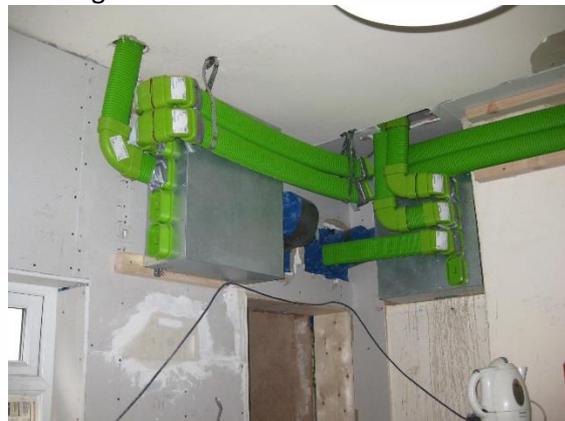
- 180mm insulated ductwork also connects unit to 2 manifolds installed on the kitchen wall. From each manifold, air is either extracted from kitchen & bathroom or supplied to 2 bedrooms & lounge via 50 x 100mm green oval-shaped ductwork.
- These ducts run to each terminal on separate runs. According to the design, restrictors are placed at the connection of most ducts with the manifold – this is in order to regulate flow rates as per the design.

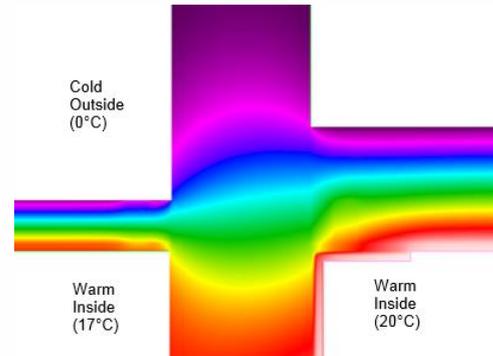
- All junctions were modelled using THERM. Where the junction was losing heat, a solution was modelled in order to reduce the heat loss so that it was close to zero.

- Problem junctions that needed a specific solution included:
 - o Party wall to loft (= model above)
 - o Party wall to ground floor
 - o Party wall to external-facing wall (in vertical profile)
- Modelling showed that using Spacetherm-P (plasterboard bonded to aerogel, a high-grade insulation material) solved the problem while also allowing the thermal bridge solution to blend in and not be too bulky. In most cases, a 20cm strip of Spacetherm-P was required.

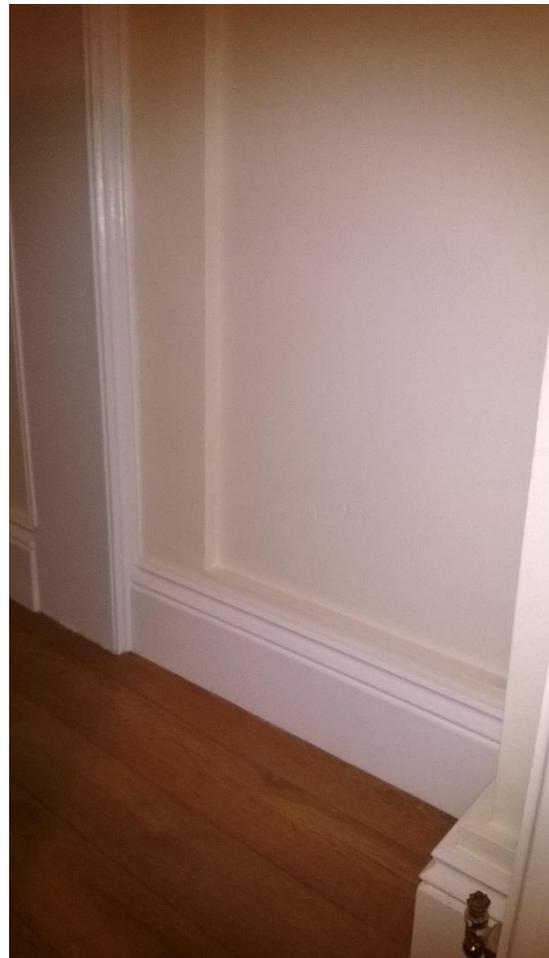
- The end result with plastering (and skirting in front) produced a surprisingly pleasing visual result that blended in well.

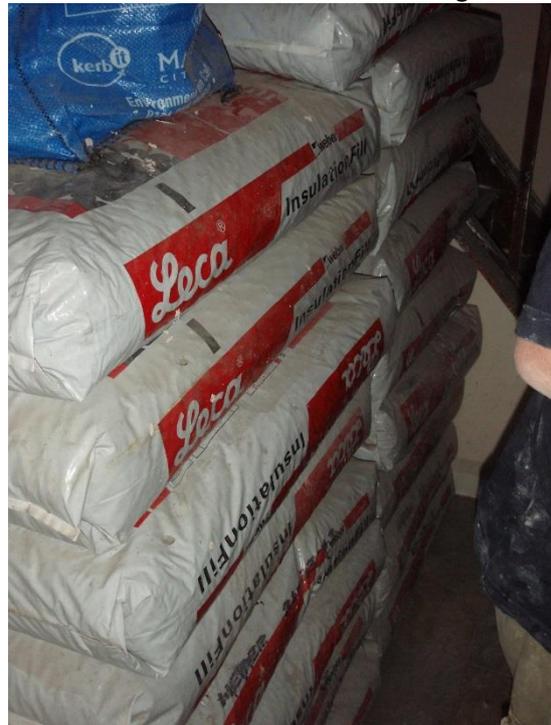
- Chimney flues were cleaned by a chimney sweep
- Chimney breasts were bricked up while leaving a small inspection hole in each one to check the Leca beads
- Leca (fired clay balls) was then added into each flue up to the level of the loft floor – we used the inspection holes to ensure that it had reached all parts of the flue. Leca has some insulating properties, but also allows moisture regulation.

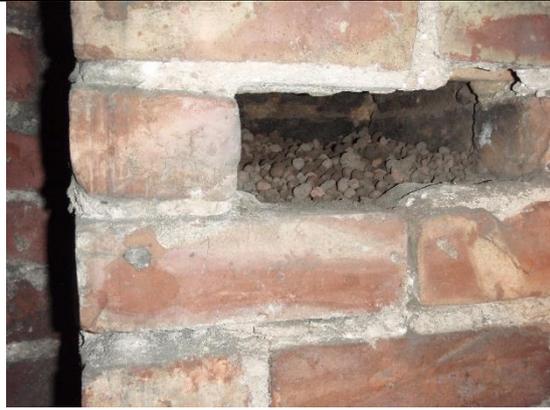
- The part of the chimney flue in the loft space up to the stack was kept empty, and air was allowed to circulate in this void by taking a brick out of each flue in the loft space. This is the part of the flue with most damp potential, so this part was where we ventilated.
