Airtightness in retrofit

A case study

19 Thornhill Road is a detached 1950s house retrofitted to EnerPHit standard (pending certification) with extensions from the 1980s and 2012, and an attached garage. The clients, architects and builders had no prior experience of Passivhaus standards or highly airtight building.

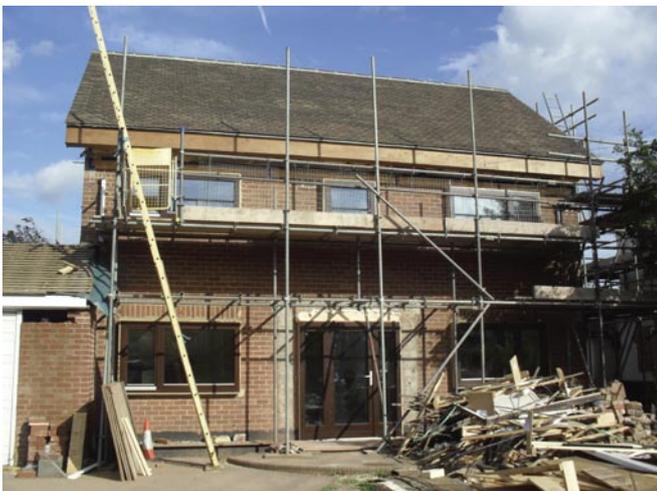
The pre-retrofit frontage of the property but with the new windows in place ready for the parge coat and external render.

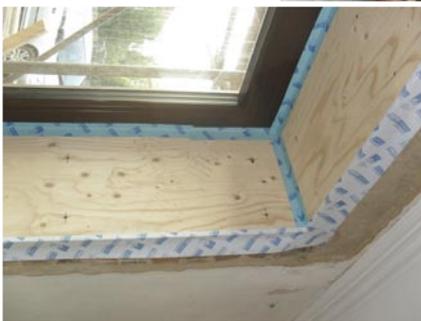
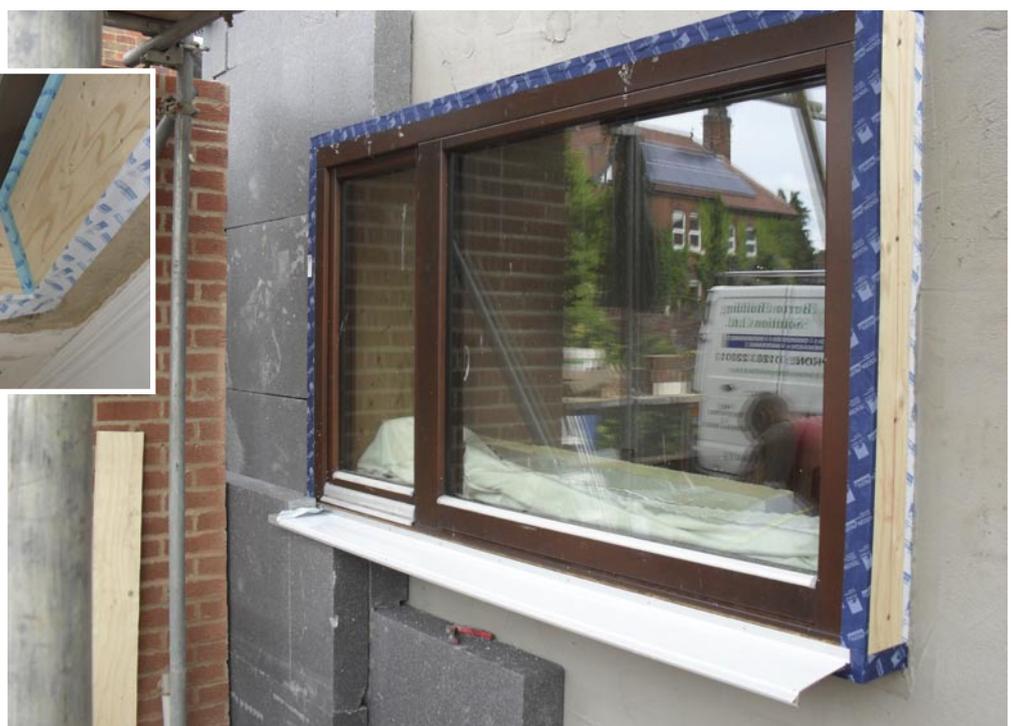
In this main photo we can see many of the details discussed in the design stage. The parge coat that was applied over the masonry; the external insulation and the detailing of the window boxes. The internal view of the window box can be seen in the inset photo above.

The main airtight layer on the brick walls is the external cementitious parge coat. The internal wet plaster is a secondary, imperfect layer. The external wall insulation itself consists of two cross-bonded layers of EPS. All joints are filled with phenolic foam, and the render coats are continuous and sealed to the windows and doors. This sounds airtight - but isn't. Aside from the flaws in installation (of which I'm sure there are many - the installers needed extremely close supervision to work to spec. The insulation is unavoidably unsealed where it hits the roof gables or goes between the I beams into the roof insulation at the eaves. The parge coat was therefore essential.

Windows and doors are boxed out into the insulation with 18mm ply (the doors are braced from beneath using Compacfoam high density polystyrene). The ply is sealed to the units with tapes externally and internally, and into the parge coat and plaster externally and internally.

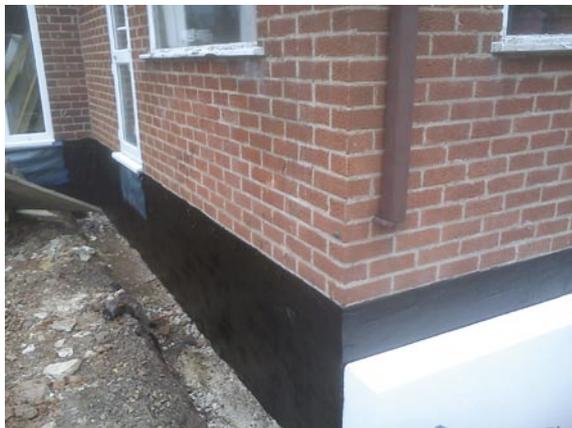
Below: view of the insulation detailing below DPC level and underground.

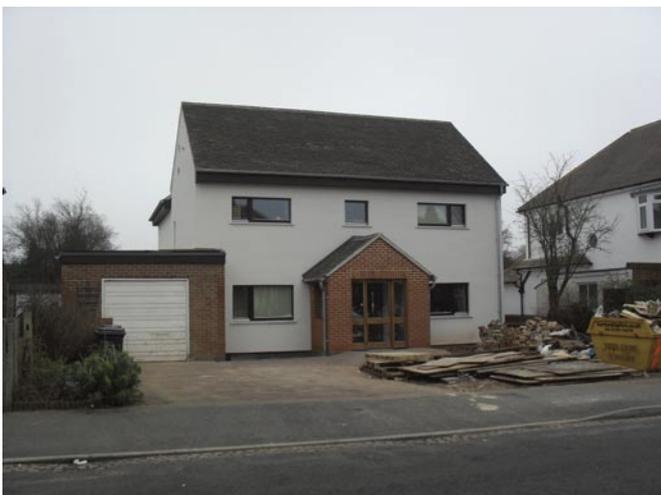
Regardless of how well the work is carried out, every home has to be pressure tested after completion to ensure that no parts were omitted in error. The fan was mounted in a window so that all doors could be air tested properly.

a window-mounted fan to remove the paradox that while doors are often a major source of leakage, one door is usually eliminated from testing by mounting the fan into it. With no real idea at all what our result would be, the whole team were extremely pleased to find out we'd made it very respectably below the 1ACH required for EnerPHit certification.
