Ladybarn, Manchester

Project description	Whole house retrofit of mid-terrace house, built c.1888.			
Treated Floor Area	60.5 m ²			
Dates of work	2013			
Project team	Myself (PHPP analyst, project coordinator & builder labour), a local contractor team (Expert Home Extensions), plus additional contractors for plumbing, electrics and plastering.			
Introduction	The house was cold and draughty, with several air bricks at various points in the walls. The bathroom in particular was always cold. The client borrowed some temperature sensors, and we estimated an average temperature in the house of around 15°C, since the client heated only some rooms and not others. The renovation was done as a full-blown learning exercise, where the client agreed to take the risk with us regarding the measures being suggested and projected costs (which ended up being double what I originally estimated). However, accurate timesheets with allocated hours per job has allowed me to have a much better estimate of what various improvements cost (e.g. cost of internal wall insulation per m ²).

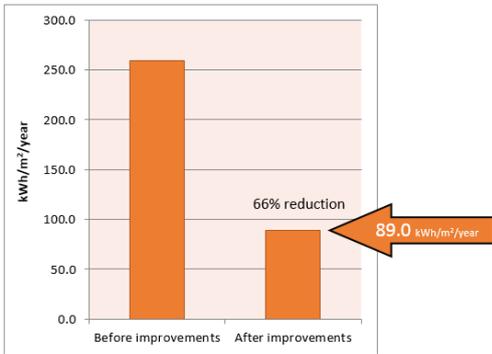
Space heating demand & carbon emissions – before and after according to PHPP		Before	After	% reduction
	Space heating (kWh/m ² /yr)	258.9	89.0	66%
	CO2 (kg/m ² /yr)	91.7	39.3	57%
	Space heating demand before & after:

This is the space heating demand before and after the retrofit. Note that this was based on assuming the house was being heated to 20°C before and after. In reality, with a previous average temperature of 15°C and yet planning on heating the house to 20°C after, space heating demand saved reduces to 29%.	This is the breakdown of the 66% savings in space heating demand (assuming the house was being heated to 20°C before and after). The biggest saving is due to airtightness and MVHR.

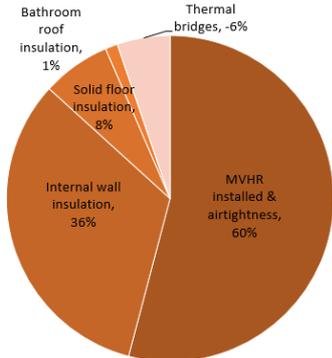
Breakdown of savings in space heating demand:

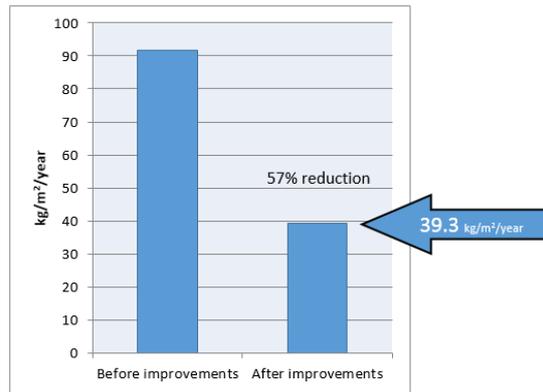
Carbon emissions before & after:

This is level of carbon emissions before and after the retrofit. Note that this was based on assuming the house was being heated to 20°C before and after. In reality, with a previous average temperature of 15°C and yet planning on heating the house to 20°C after, carbon emissions saved reduces to 26%.

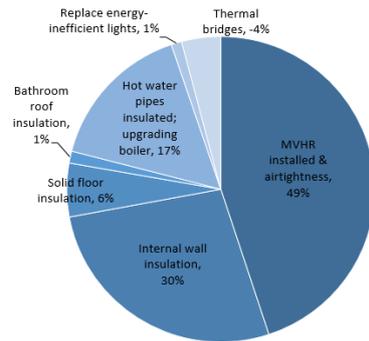
Breakdown of carbon savings:

This is the breakdown of the 57% savings in carbon emissions (assuming the house was being heated to 20°C before and after). The biggest saving is due to airtightness and MVHR.

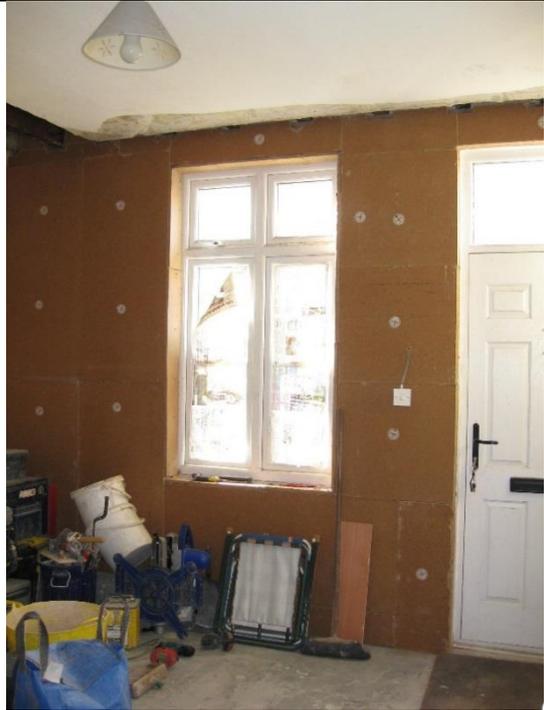
Improvement	U-values / information
Insulation	
Bathroom loft	- Mineral wool 320mm thick, u-value 0.127 W/m ² K
Loft	- Mineral wool 300mm thick, u-value 0.134 W/m ² K
Solid floor	- Extruded polystyrene (Marmox) 20mm thick, laid with tile grout on solid floor, followed by underlay and 8mm laminate, u-value 1.062 W/m ² K - This was one compromise we made to avoid digging up the existing floor. Insulation thickness was dependent on the existing door thresholds.
Internal walls (external-facing – i.e. not party walls)	- Wood fibre boards 80mm thick fixed direct to wall with concrete screws and plastic washers, u-value 0.36 W/m ² K - Keim Lotexan mineral paint applied on external wall face (2 coats) to reduce rain-driven moisture into brickwork

- Insulation was continuous through floor void, which entailed cutting out floorboards and ceiling plasterboard to accommodate it.
